CIVIL ENGINEERING LABORATORY  
Naval Construction Battalion Center  
Port Hueneme, California

EXPERIMENTAL STUDIES OF FATIGUE  
FAILURES OF DOWN LEAD CABLES

December 1976

DEPARTMENT OF CIVIL ENGINEERING  
CALIFORNIA STATE UNIVERSITY  
Long Beach, California

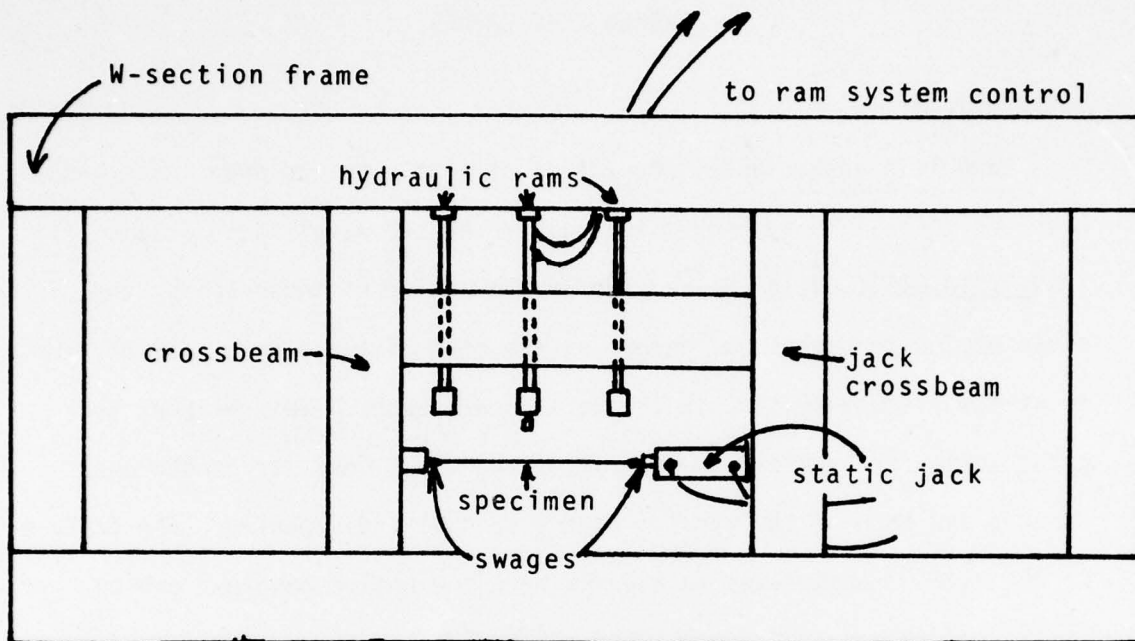
Figure 1. Schematic of Test Frame

The test frame is rectangular in shape made up of heavy W-sections with crossbeams added for structural stability. Three hydraulic rams are mounted on one side of this frame for application of static or dynamic loads or displacements. A schematic of frame is shown in Figure 1.

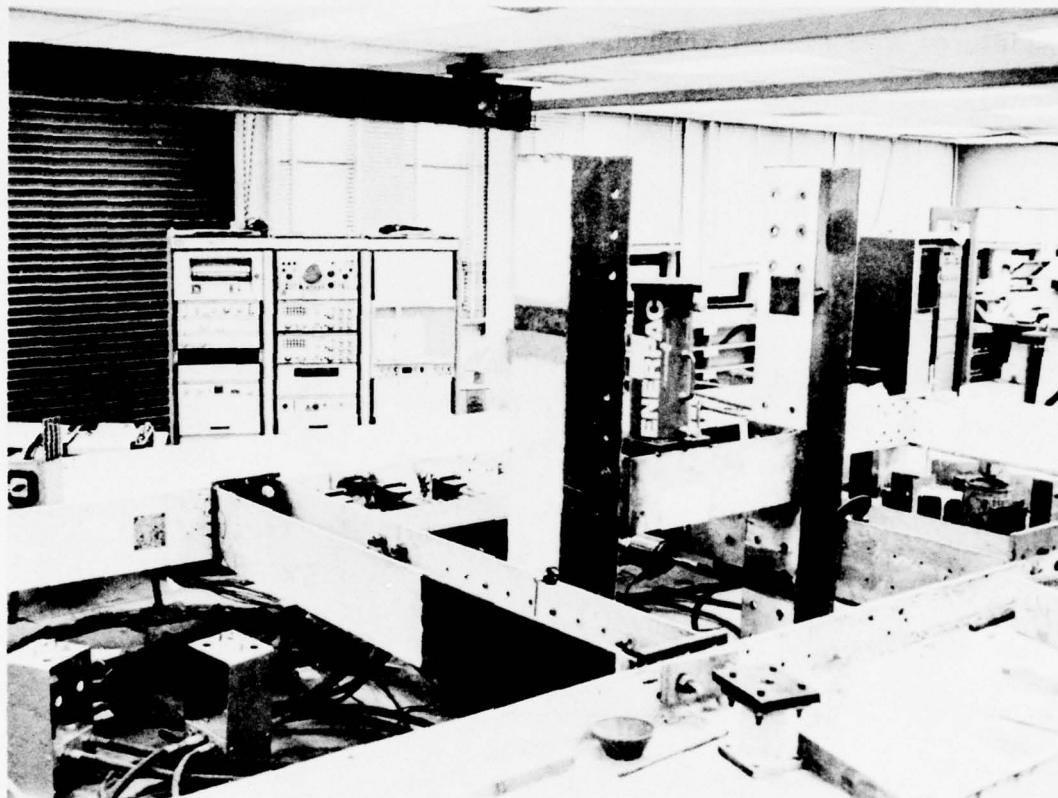
Figure 2. Loading Frame and Console

Action of the hydraulic rams is set, monitored, and controlled electronically through a system console making adjustments in wave form, amplitude, and frequency in either stroke or load modes (Fig. 2). These rams were used to apply a dynamic lateral load or torsional couple to the test specimen.

Figure 2 shows the loading frame modified for torsional fatigue test and system console.

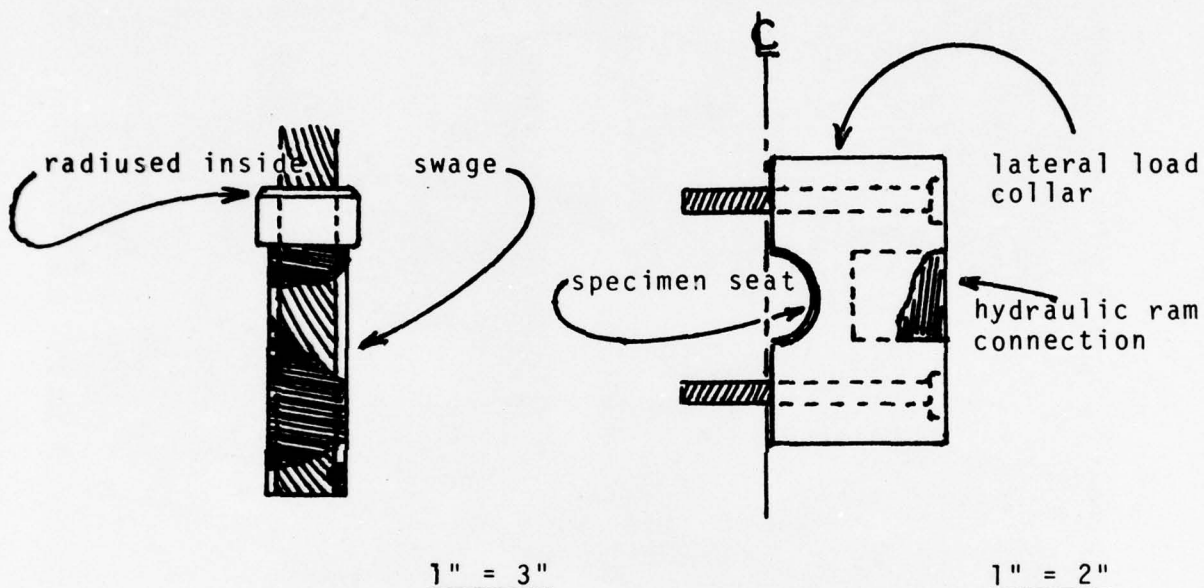
Figure 3. Swage Connectors and collar

Connectors for applying the axial static tensile load were steel cylindrical swages having an outside diameter of 1.75 inches and length of 5.25 inches with a minimum pullout strength of 30 kilopounds. Swage free ends were rounded to prevent cable abrasion or stress concentrations as the cable entered the swage.

to the cable midspan as a point load by means of a snug (not tight) collar. The dynamic torsional couple was applied from the outer rams to the cable midspan through lever arms attached to this collar. Cloth insulation protected the copper test specimen from abrasion and insured more even distribution of lateral load or torsional couple (Fig. 3).

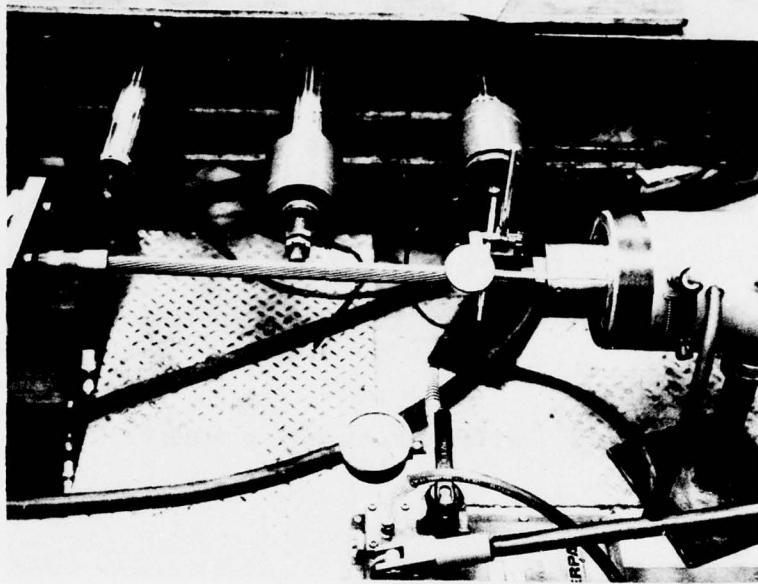
Figure 4. Dynamic Lateral Load Test Specimen in Place

Dynamic Lateral Load Test: The specimen was placed in the frame, one end attached to the tension jack, the other attached to a test frame crossbeam. The cable midspan was aligned with the center hydraulic ram by adjusting the threaded swages (Fig. 4).

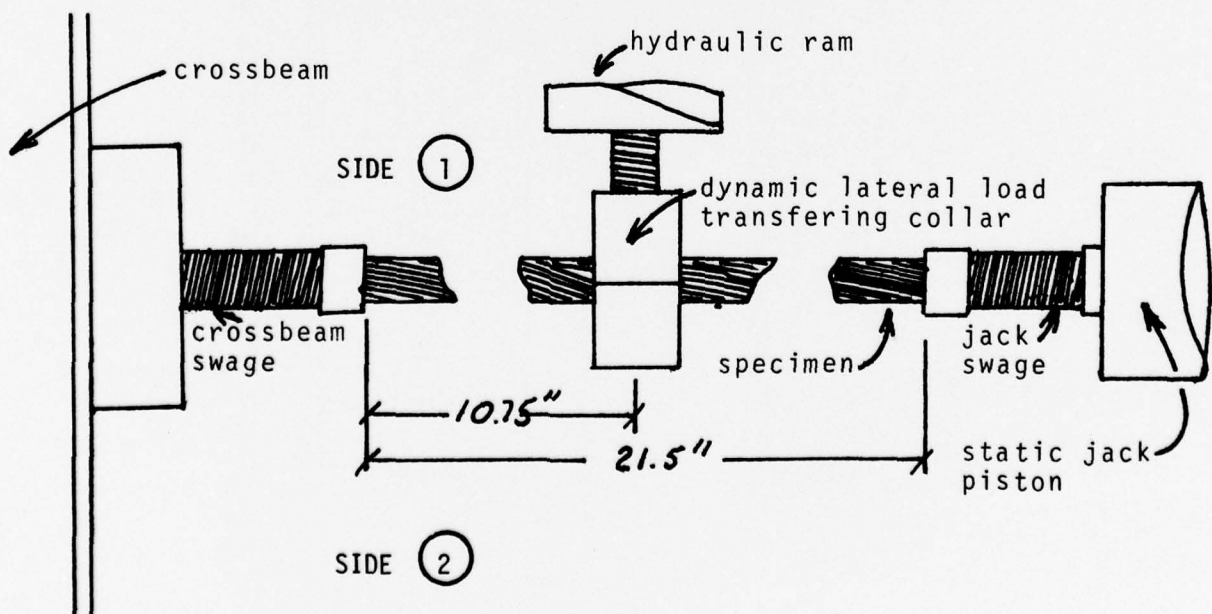
Figure 5. Test specimen set-up (dynamic lateral load)

At this point the specified axial tension load was applied in three increments and corresponding axial deflection was recorded. After full tensile load was applied the lateral load carrying collar, attached to the center ram, was secured to the cable midspan (Fig. 5).

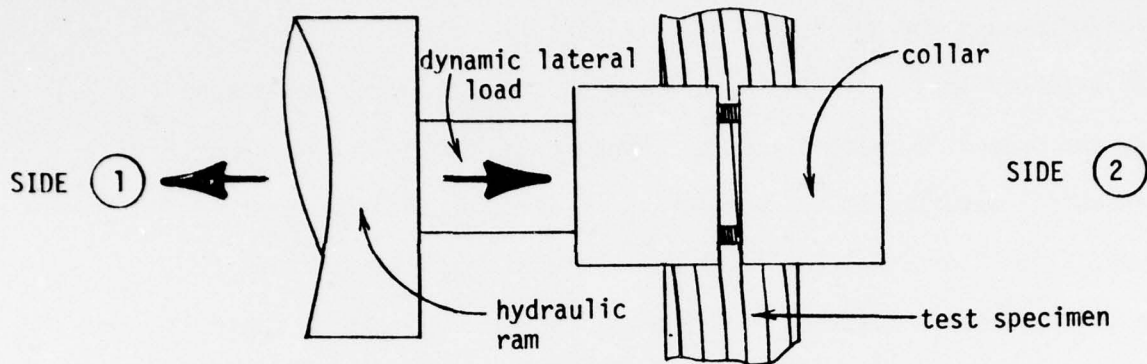
Figure 8. Convention for referencing failure sketches

Failure mode was described by number and location of failed wires, degree of strain of wires, and type of failure. Failure type was referred to as "shear" having a pronounced  $45^{\circ}$  failure plane with minor lateral strain, or as a "fatigue" failure having a cupped surface with excessive straining. These terms are only for descriptive purposes and may not exactly describe the failure mode. In addition, for each specimen a description and sketches are provided in Appendix A of this report. For orientation to specimen photographs, sketches are referenced with "side 1" corresponding to the side of test specimen nearest the hydraulic ram, and "side 2" corresponding to the test specimen side furthest from the hydraulic ram (Fig.8 ).

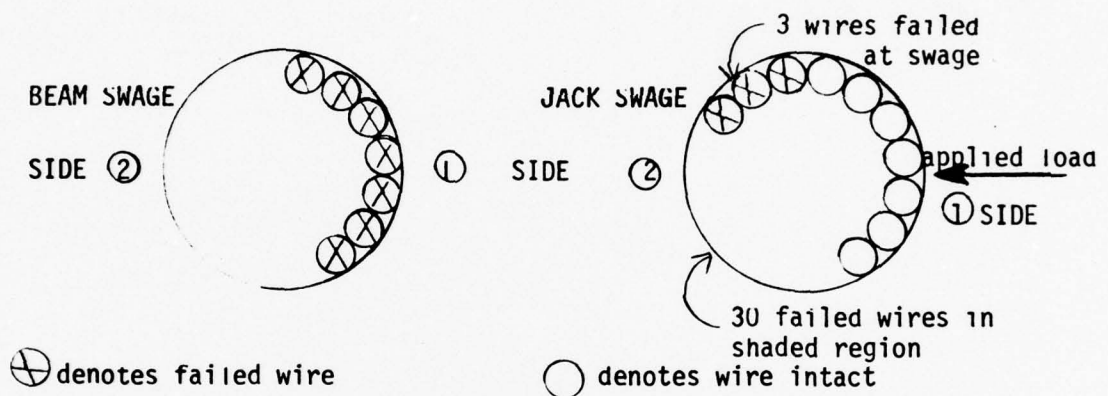
No. 1

Cable failed at both ends inside swages. This test is considered static since a full cycle was never achieved. Location of failed wires is as noted

Most wires failed well within the swage. Average depth into swage to failure point is .645". The only visible copper wire deformation is at the point of collar contact and within swages. Within swages wire deformation is considerable. While at the collar contact, the deformation is not as significant. This deformation, coupled with large angle of rotation and subsequent high bending stress is probably responsible for failure in the swages. Figure shows deformation due to swaging and type of failure.

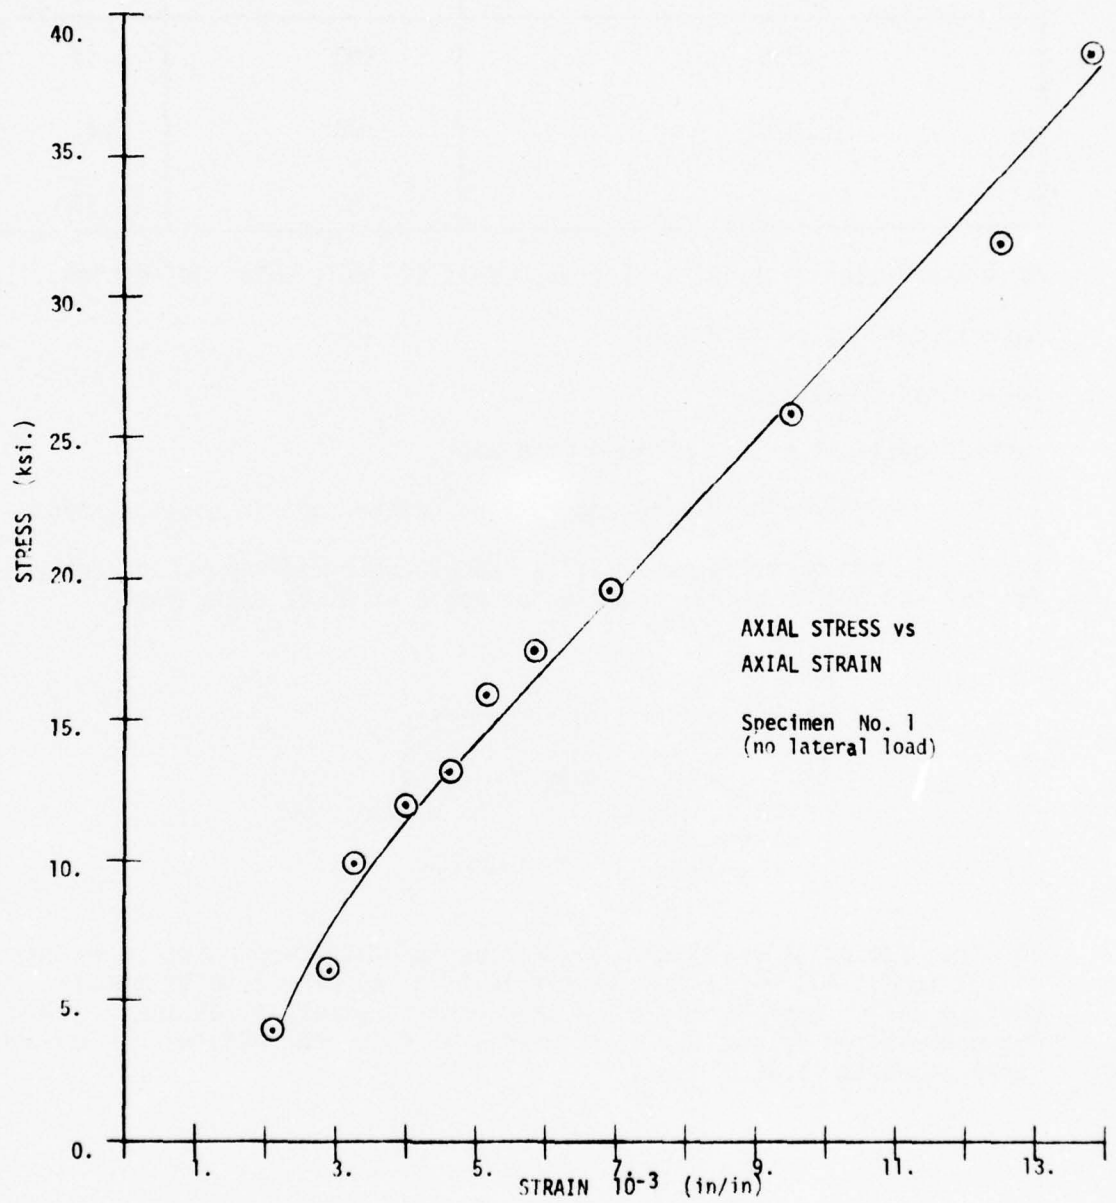
Static loads vs. longitudinal deflections  
on the first specimen

1. Load: 0 (second time loads were released)  
Cable diameter: 1.005 in.  
Elongation: .032 in.
2. Load: 14,800 lbs. (fourth loading)  
Cable diameter: .995 in.  
Elongation: .154 in.
3. Load: 20,000 lbs.  
Cable diameter: .994  
Elongation: .21
4. Release load to 0 lbs.  
Cable diameter: .995  
Permanent set after 1 load of 20,000 lbs: .058 in.
5. Load to: 25,000 lbs.  
Cable diameter: .995  
Elongation: .274
6. Load to 30,000 lbs.  
During loading, the apparatus readjusted itself  
Cable diameter: .254 in. (after slippage, the elongation at  
30,000 lbs. was only .254 in while the elongation  
at 25,000 lbs. was .274 in.
7. Release load to 0 lbs.  
Cable diameter: .995  
Permanent set: .098 in.
8. Reload to 30,000 lbs.  
Elongation: .299

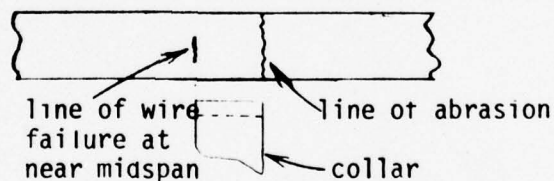
6 wires in the outer layer failed at about cable midspan. Apparently,  
failure was due to collar abrasion of cable wires at outer layer.

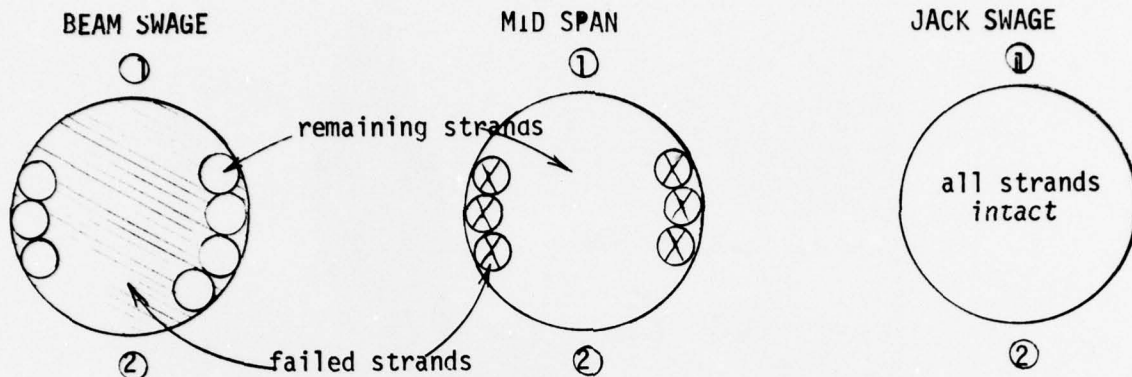
Specimen No. 2

30 wires failed at swage with average depth of failure point in swage  
of .09 inch. All outer layer wires that failed here were at swage  
surface while inner wires failed at depths as great as .39 inch. Abrasion  
was moderate on second layer (12 wires) at swage and heaviest on second  
layer at about cable midspan.

It is not known which wires failed first. However, it is likely that midspan failure occurred first due to high abrasion from collar and that swage failure followed due to excessive axial load on remaining strands and large lateral deflection of cable at midspan with ensuing high end moments.

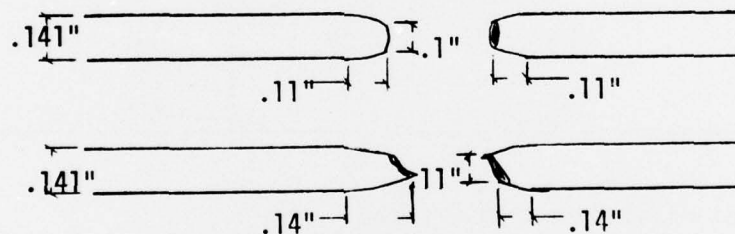
It should be noted that lateral displacements were constantly high (1.5") relative to short specimen length (21.5"). Failures appeared as shown here.

Abrasion was highest at midspan on second layer (12 wires) decreasing slightly at swages. In general, degree of abrasion was moderately high.

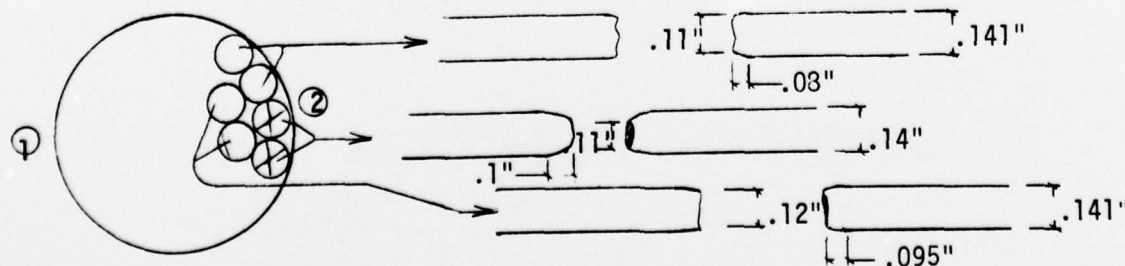
At 4300 cycles 2 wires in outer layer failed at jack swage, as noted below by X.

Failure here was probably due to swage abrasion of wires on specimen outer layer. Ultimate failure followed rapidly with only five strands remaining at crossbeam swage. Four additional strands broke at the jack swage as noted above. Failed wires at crossbeam swage showed signs of bending

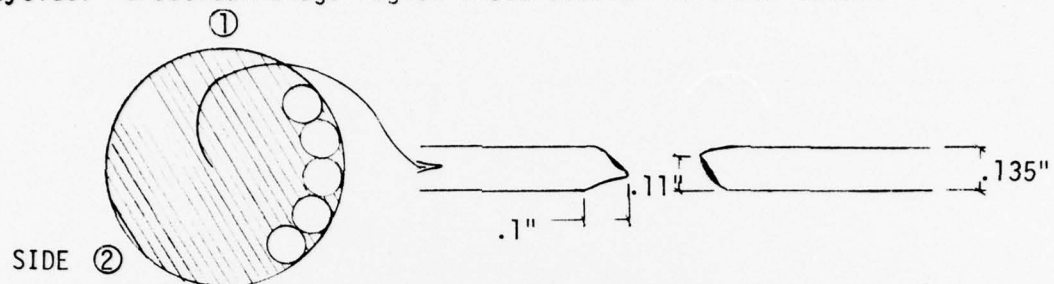
failure due to high lateral midspan deflection during the last few cycles. Crossbeam swage region cross-section is shown below.

Moderate straining occurred at the crossbeam swage indicating that this region was probably approaching failure at 4300 cycles. Abrasion was high on second layer (12 wires) at midspan and at both swages.

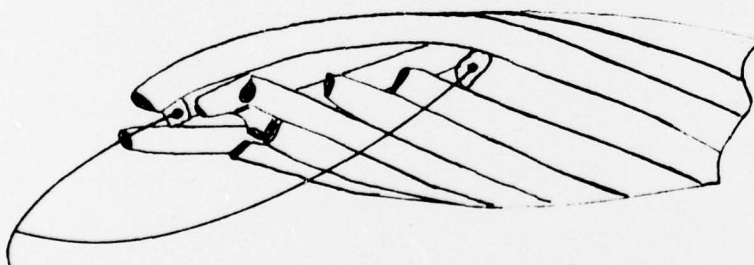
first inner layer  
(12 wires) with  
outer wires removed

yielding at about cable midspan. Failure pattern of the inner wires is drastically different. The line of failure of successive wires in a given layer is along the same line as wire of successive inner and outer layers.

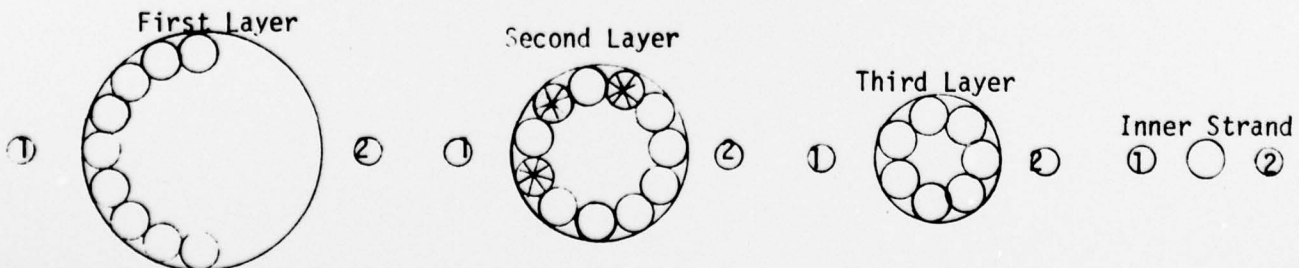
Two wires in second layer (12 wires) showed little strain, with a smooth failure surface, i.e.,

with plane  $\approx 45^\circ$ . All other wires in this layer failed with high strain, i.e.,

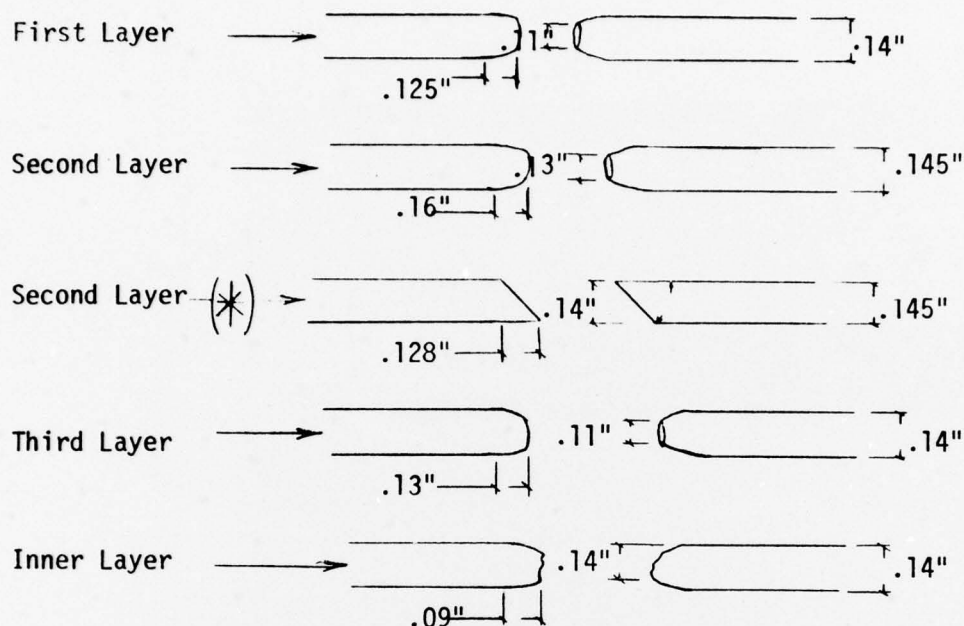
Abrasion on the outer layer of wire was visible but probably had negligible effect. Abrasion on the second and third cable layers was moderate and probably led to stress concentrations, reduced area, and eventual fatigue failure of these wires at points of bearing on wires of other layers. The inner layer (one wire) showed no sign of abrasion. Most abrasion occurred between the second and third cable layers. The failed end of the inner layer wire appears to have been initially a cupped shear failure subsequently further damaged by butting of the failed ends against each other. The degree of subsequent damage to the inner layer wire after initial failure indicates that this wire may have been among the first wires failed within this specimen. It should be noted that this test terminated 30 cycles after failure of the first wire at which time only nine strands (all in the outer layer) remained intact.

Wires in the region of the swages regardless of layer show no sign of failure. There is some abrasion due to wire contact stresses on the second and third layers but this abrasion is minor at the swages increasing along the wire length to its maximum at midspan.

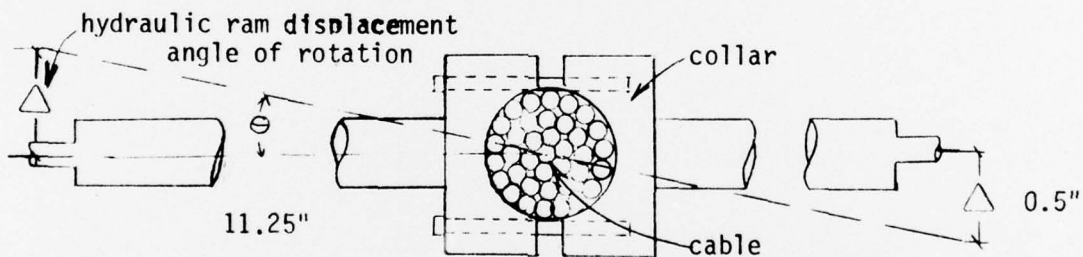
\*  $\Delta$  is deflection of torsion arm at free end in direction of applied load.  
Degree of cable rotation at midspan due to applied torsion is found as  $\arctan \Delta"/11"$ .

$$\tan^{-1} (.5/11) = 2.6 \text{ degrees.}$$

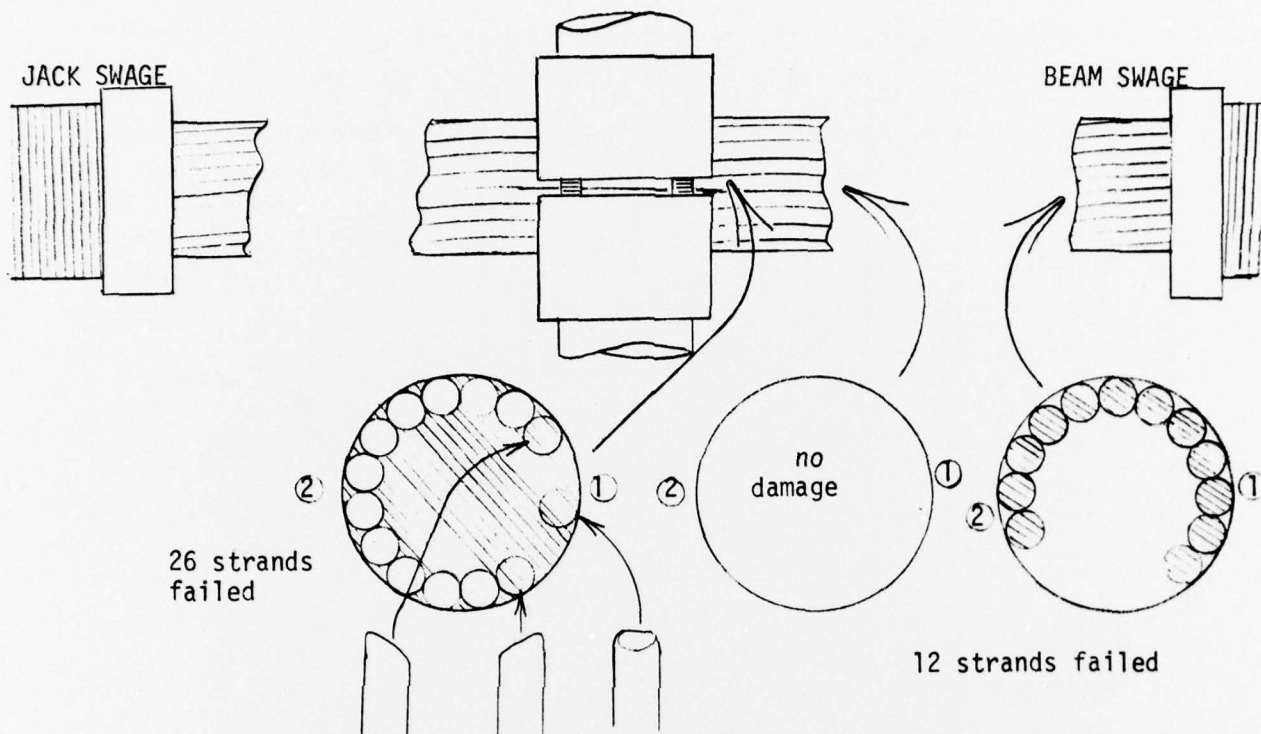
Primary failure occurred at point where 12 strands cable entered collar.  
At this place, failed necking is slight.

Failure planes of individual wires indicate shear failure (no cup) during a twisting. Failure was due to excessive pressure from collar. Data from this specimen is questionable. 12 strands from outer layer failed at the base swage. Mode of failure was similar to that previously described. Excessive tightness of collar is indicated by extreme deformation of intact outer strands both entering and leaving the collar.

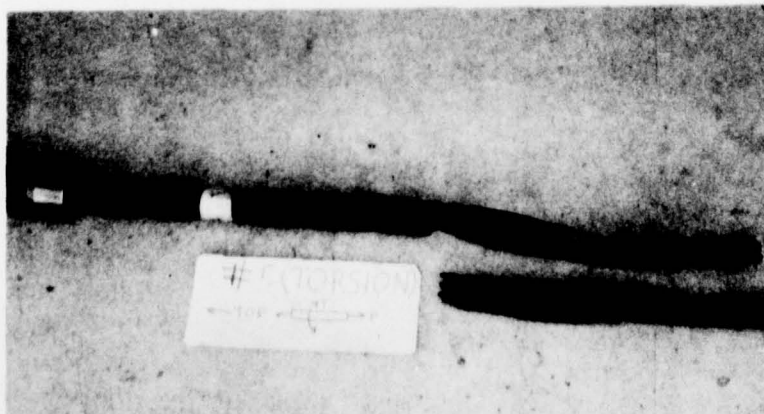
Abrasion between wire layers within the collar is extreme, but throughout the rest of cable there is no evidence of abrasion.

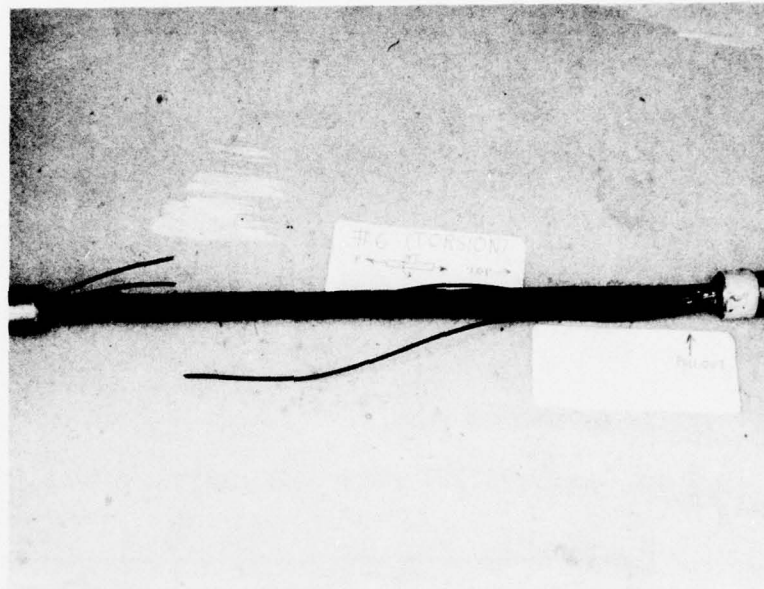
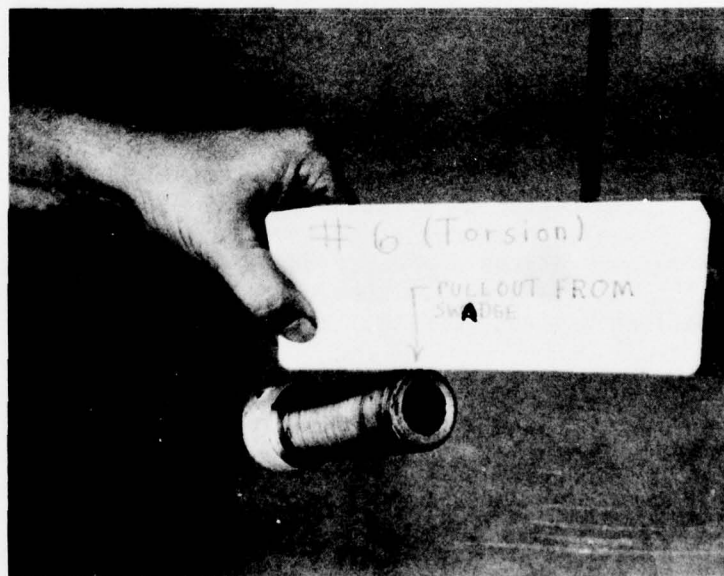
Specimen No. T6  
Axial Load: 10-30 kp

Failure occurred in static jack swage with complete cable pullout. Copper wires showed a high degree of abrasion between outer (18 wires) and first (12) layers. Abrasion occurred at contact points of wires from each layer. Abrasion was maximum at cable midspan decreasing toward swages. At swages little abrasion was visible. It should be noted that the cable itself did not fail. Failure was with the test apparatus (Swage).

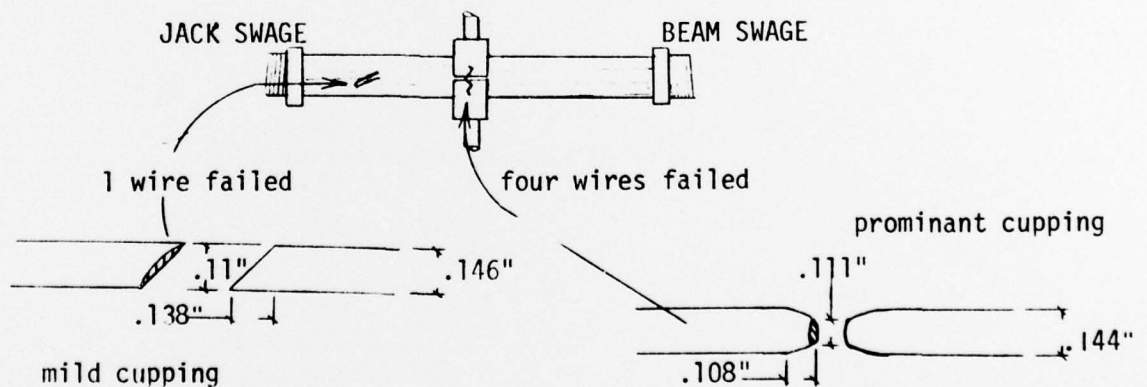
Failure occurred in one strand at about cable quarter span. In addition, four strands failed at mid-point of cable, within collar. All failed strands were in outer layer. The outer cable layer showed strain in excess of that occurring in other layers. Additional strain was measured at .044".

Abrasion occurred between outer (18 wire) and first (12 wire) layers. At cable midspan abrasion was high and decreased to low at swages.

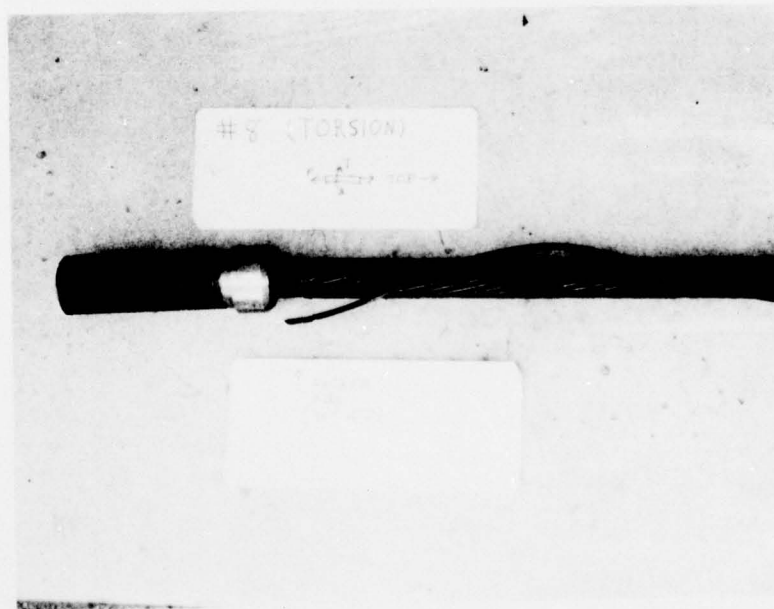
Specimen was fatigued at 30 kips axial load and 4.0 kip inches torsional load for 10,000 cycles. At this point axial load was increased to 33 kips. Failure occurred after 13 additional cycles. Failure was of one strand in outer layer at base swage.

Failure plane was about 45° with very little local strain. However, entire outer layer of cable showed strain in excess of other layers of about .047\".

Abrasion occurred between outer (18 wire) and first (12 wire) layers. Abrasion was moderate at midspan and decreasing to insignificant at swages.
